# Assessment and Analysis of the Plaster Exhibit Hall Ceiling at the Wagner Free Institute of Science, Philadelphia, PA

Marlene Lauren Goeke  
*University of Pennsylvania*

A thesis in Historic Preservation Presented to the Faculties of the University of Pennsylvania in Partial Fulfillment of the Requirements of the Degree of Master of Science in Historic Preservation 2008.

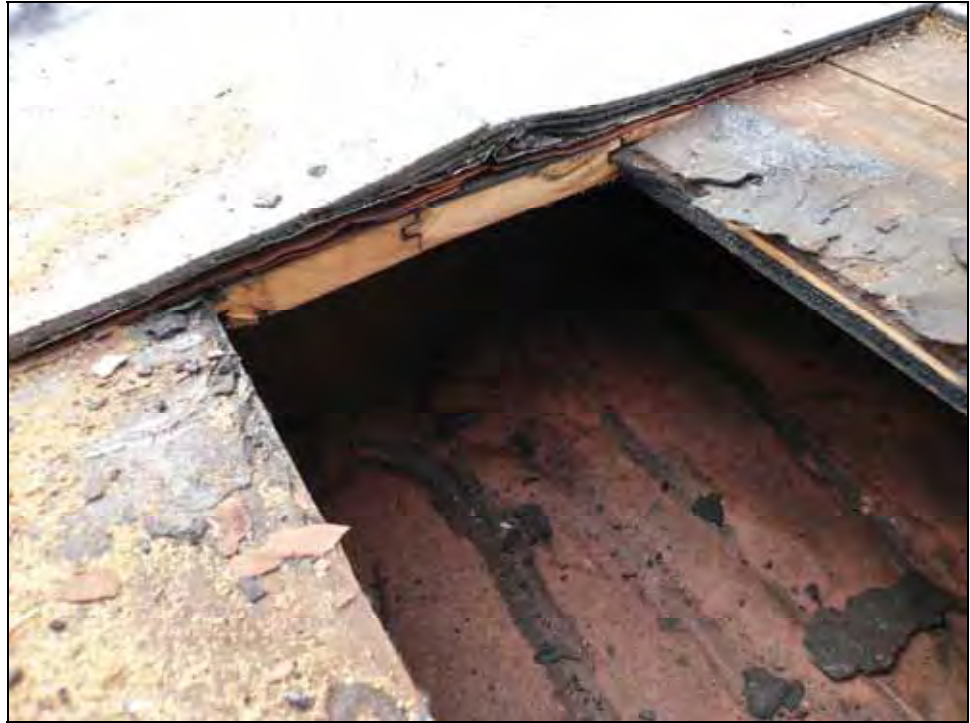
**Figure 10: Probe 2, above area of water staining and displacement. Note the layers of roofing material and the water damage to the roof paper. Photo by M. Goeke, 2007.**

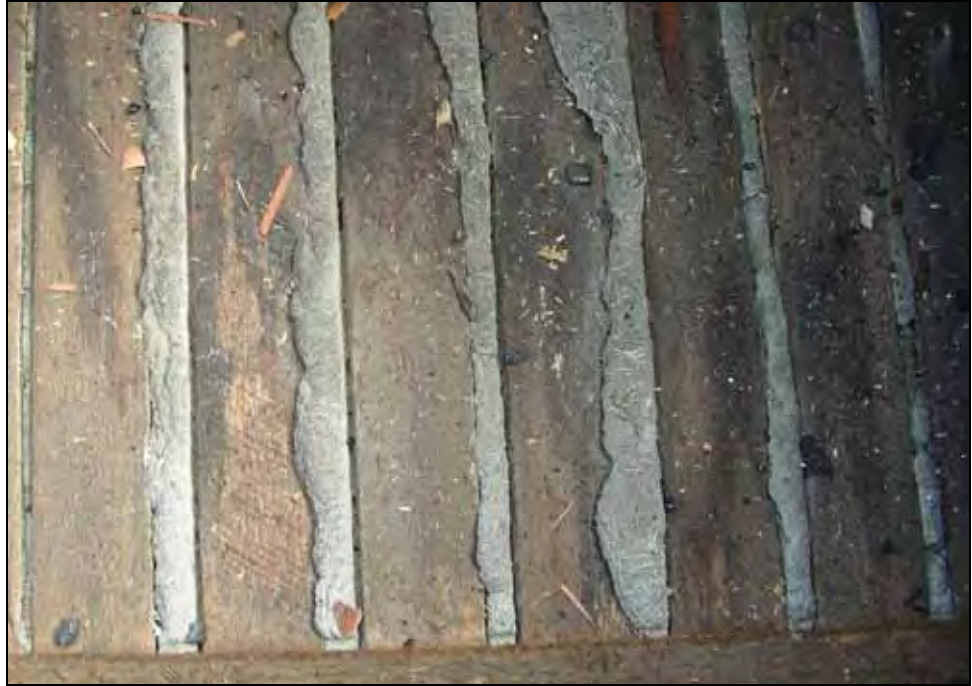
The lath that was inspected also appeared to be in good condition. In Probe 6, however, damage was visible due to warping and twisting of the lath. Probe 6 was over an area of water staining, so damage to the wood from water is likely. In some places, gaps exist between the lath and the key, perhaps from drying of the wood (or in combination with shrinking of the plaster). These small gaps between the plaster keys and the lath have implications on the stability of the plaster.

**Figure 15: Probe 2. Gaps between lath and plaster may indicate drying and shrinking of the wood. Photo by A. Finke, 2007.**
